Wired Flat Panel Detector

Wireless Flat Panel Detector

Superior Image Acquisition and Processing System

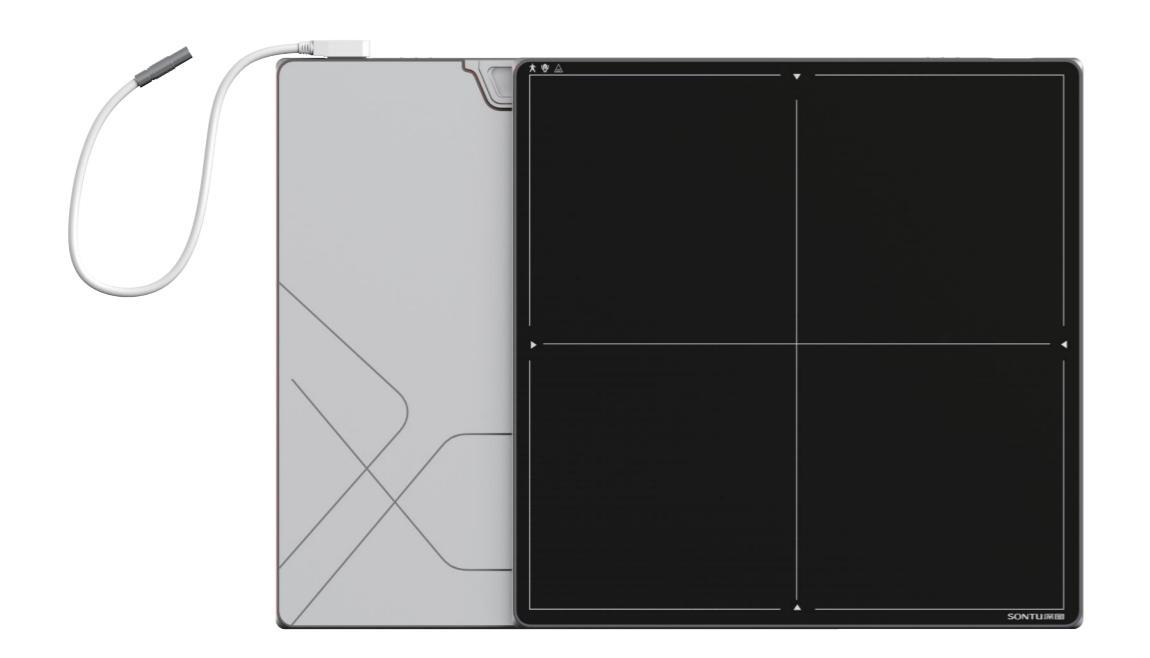
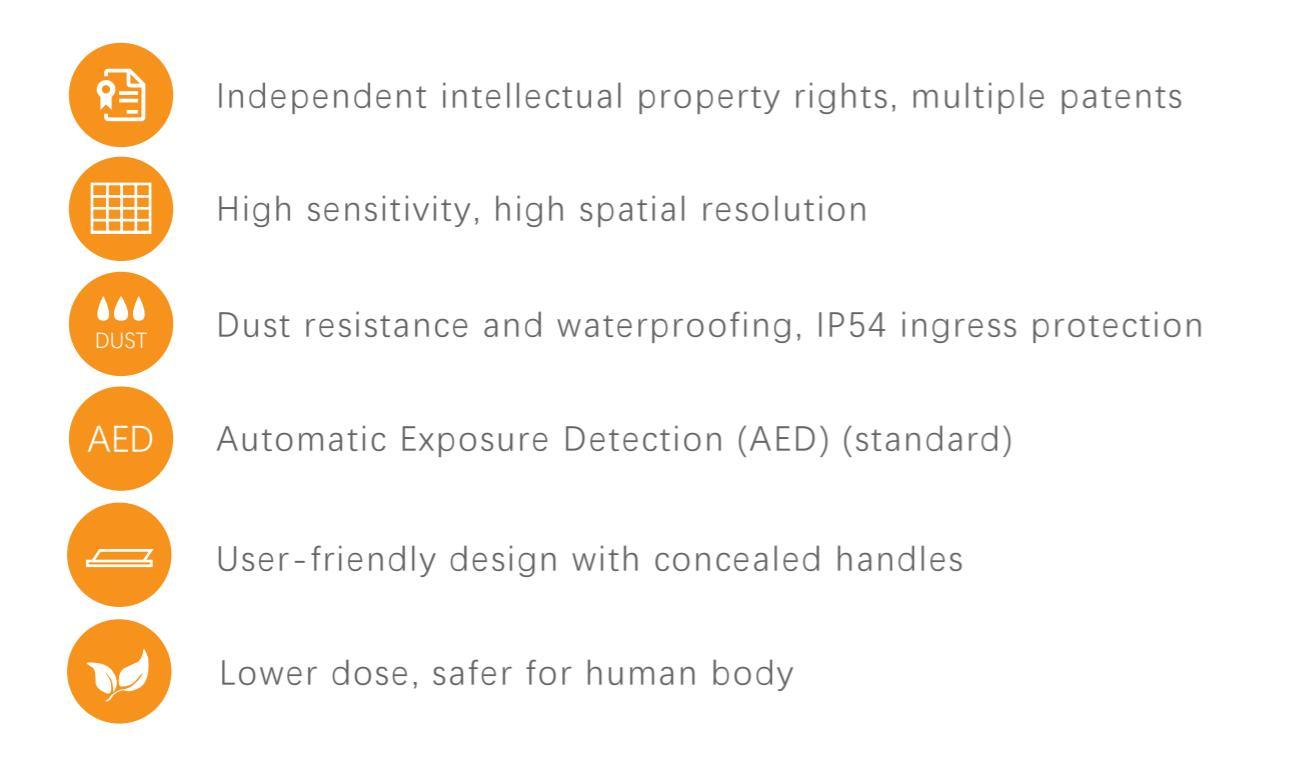
Vincent Medical's flat panel detector supports two size options(14"*17" & 17"*17") to meet different clinical imaging requirements for veterinary use.

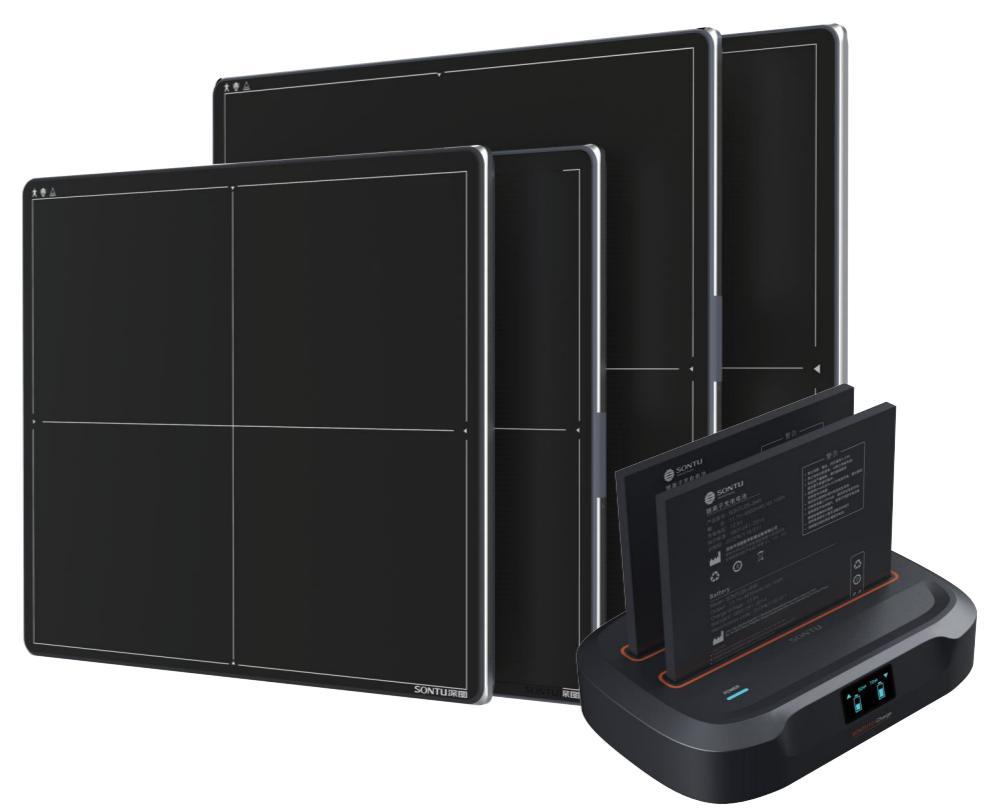
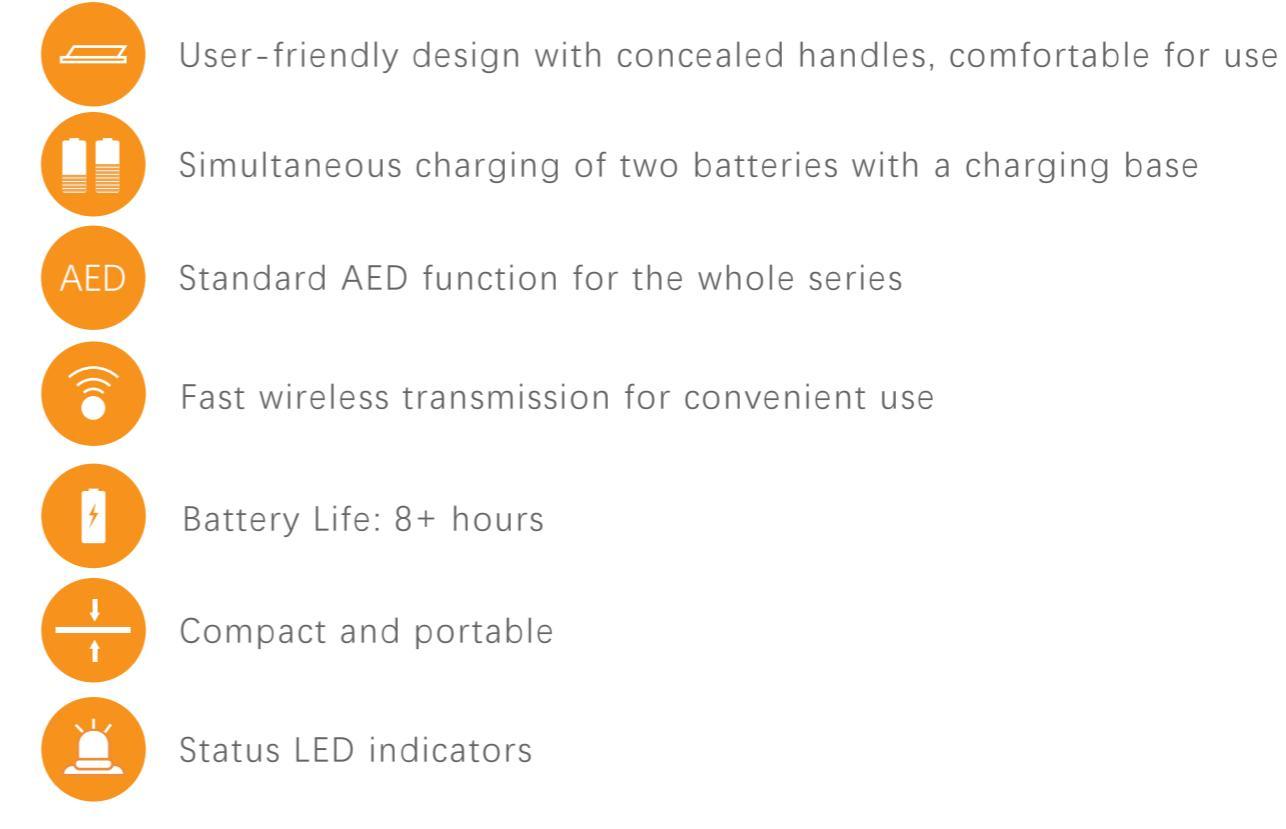
Vincent Medical's wireless flat panel detector features more accurate AED, clearer image details, and longer battery life.

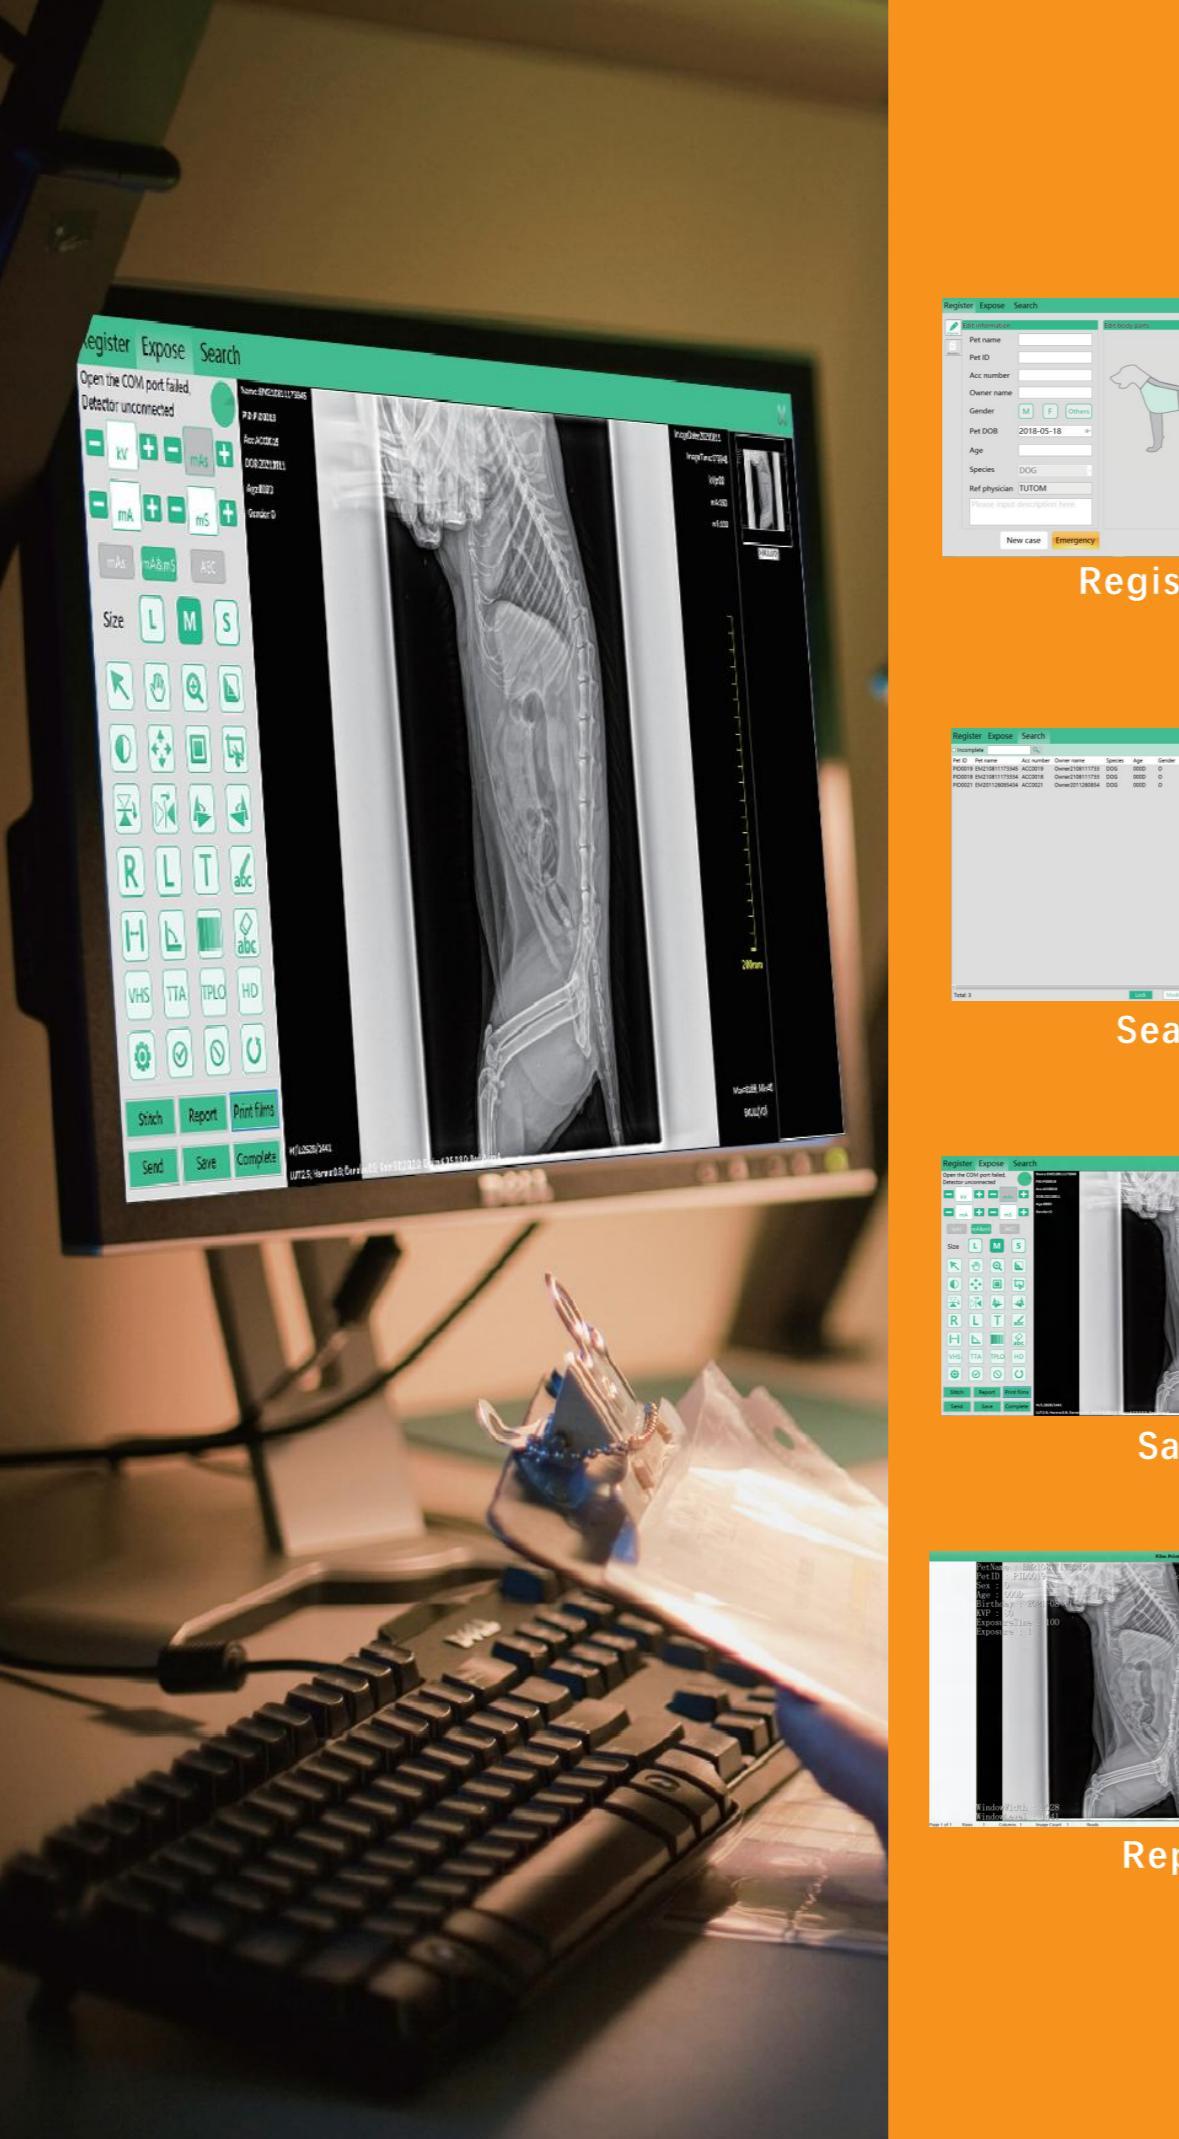
Registration wire rame Specie Age Gender View body parts Oest damo Oest sim eme/108111735 D06 0000 SKULL/P0_SKULL(PV_SKULL LAT, 28210811 173345 eme/108111735 D06 D000 SKULL/P0_SKULL(PV_SKULL LAT, 28210811 173345 Search Sava Report

Vincent Veterinary Workstation is an image acquisition and processing system designed and developed by SONTU. With animal body characteristics and structural differences considered, it ensures the best image acquisition at the lowest exposure dose and has obtained the computer software copyright from the NCAC. Easy-to-use interface, smooth and intelligent operation process, support emergency quick exposure and DICOM image export and data retrieval.
